**Flood Control Project Maintenance
Levee Inspections**
LMA District Cover Sheet
Spring 2018 Levee Inspection Results

Reclamation District No. 0003 Grand Island

Spring 2018 Levee Inspection Results

| Waterway | | | Bank | Unit Miles |
|--|---|---|---|---|
| Unit No. 01 Left Bank Steamboat Slough | | | Left | 10.95 |

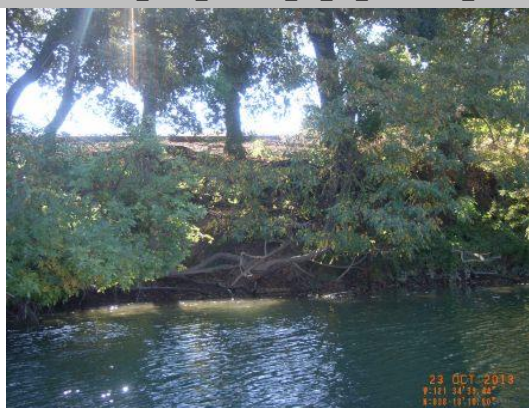
Photo 1 of 1 : SP_2018_RD0003_24_10_20180305_00015.jpg

| 1997 - Mass failure of berm slope and wave wash erosion. Large trees on top of berm, some failed trees. New area of low rock to on the upstream end. 2000 - Some minor erosion near the downstream end. 2005 - One new small tree has fallen. 2009 - Minimal new erosion. 2010 - Minor new erosion. 2013 - Observed new animal holes and vertical sections at middle of site. 2015: Minor new erosion. [2015 Site ID: STM_26-0_L] | | | | | |

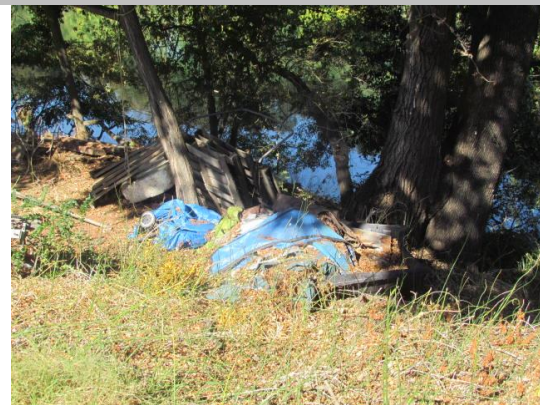
Photo 1 of 4 : SP_2018_RD0003_24_188_20180305_00089.jpg

Looking southwest at garbage on waterward berm. (Fall 2014)

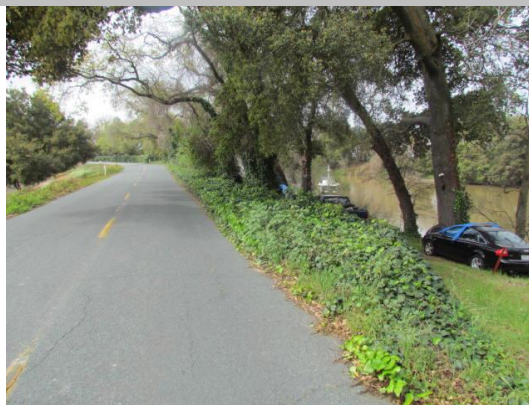
Photo 2 of 2 : SP_2018_RD0003_24_6_20180305_00008.jpg

Looking southwest at landscaping on waterside shoulder and slope.
(2015)

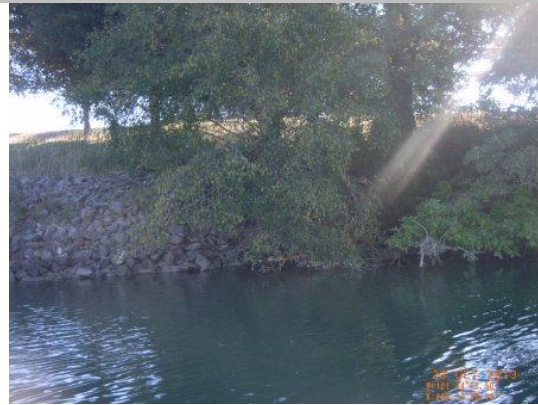
Photo 1 of 1 : SP_2018_RD0003_24_4_20180305_00006.jpg

| 1997 - Erosion of sandy levee on top left bank. Site is downstream of a rock section. Large riparian trees on the bank. 1999 - Upstream half of the reach repaired with rock, except for a 30 ft reach at the upstream end. 2001 - Rock repair on the upstream and downstream ends; no revetment at the trees. 2002 - Rock repair is starting to slide off the geotextile at the upstream end. 2005 - One new small tree has fallen. 2006 - 50 ft pocket at the downstream end and at the upstream end with new rock in between. 2007 - Upstream end has been repaired. 2010 - Some minor new erosion. 2011 - Minor new erosion. 2012 - Minor new erosion at the toe. 2015: Significant new erosion, large oak tree on verge of popping out. [2015 Site ID: STM_25-0_L] | | | | | |

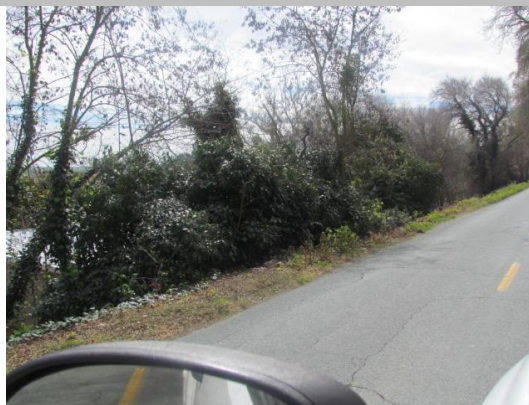
Photo 2 of 2 : SP_2018_RD0003_24_12_20180305_00017.jpg

Looking southeast at landscaping on landside slope.

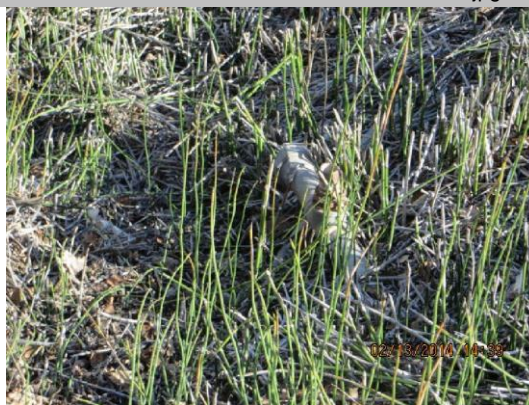
Photo 3 of 3 : UCIP_SP_2018_31287_57296.jpg

Pipe visible just off LS shoulder in vegetation.

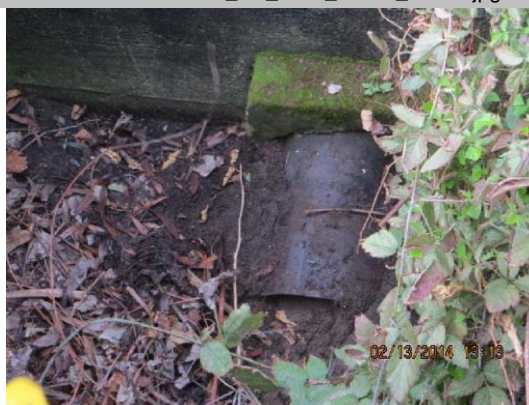
Photo 1 of 2 : UCIP_SP_2018_29567_54634.jpg

| FS_ID:29567 DS_ID:22146 EP_NO: N/A Repair Type: Non-Urgent Crossing Status: Found UCIP Comments: Need to verify proper abandonment of irrigation pipe. FIELD_STRUCT_DESC: *ABANDONED* 10-inch steel irrigation discharge pipe through the levee, invert elevation 4.2 feet below the crown. 5-foot by 7-foot concrete distribution box at the landside (LS) toe. Cannot see pipe on the waterside (WS). [Additional Reference(s): DWR Levee Log, 1993. USACE Sacramento O&M Manual 104, February 1960, (RM 23.55)]. FS Date: 2/13/2014 | | | | | |

Pipe visible inside concrete distribution box on LS toe.

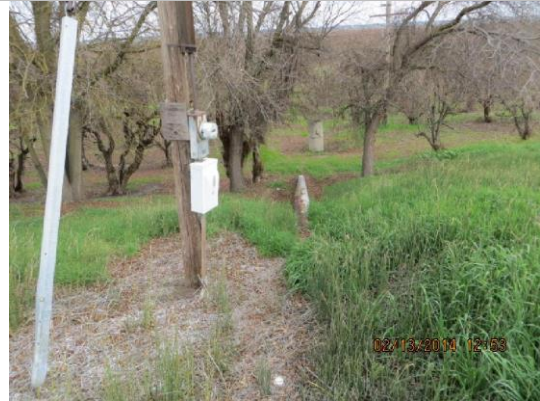
Photo 3 of 3 : UCIP_SP_2018_29563_54620.jpg

| FS_ID:29563 DS_ID:22148 EP_NO: N/A Repair Type: Non-Urgent Crossing Status: Found UCIP Comments: Pitted holes on slant pump intake may indicate internal problem. Good candidate for video inspection. FIELD_STRUCT_DESC: 14-inch steel irrigation discharge pipe though the levee, invert elevation 6.3 feet below the crown. Service pole on the landside (LS) slope. 1.5-inch electrical conduit through the levee to the pump on the waterside (WS). 36-inch concrete standpipe at the landside (LS) toe. [Additional Reference(s): DWR Levee Log, 1993, 16-inch pipe referenced. USACE Sacramento O&M Manual 104, February 1960, (RM 23.17), 16-inch pipe referenced]. FS Date: 2/13/2014 | | | | | |

Pipe and standpipe visible on LS toe. Power pole and meter on LS slope.

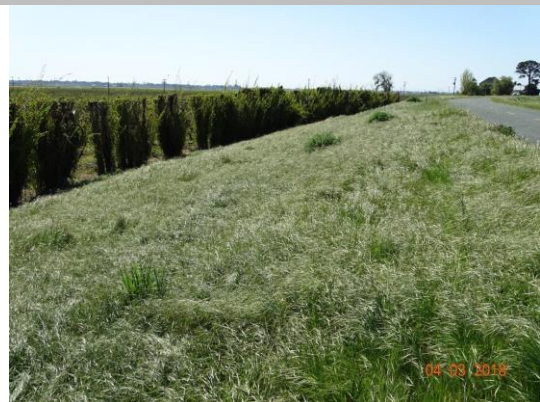
Photo 1 of 1 : SP_2018_RD0003_24_68_20180403_00175.jpg

Closely spaced trees along toe.

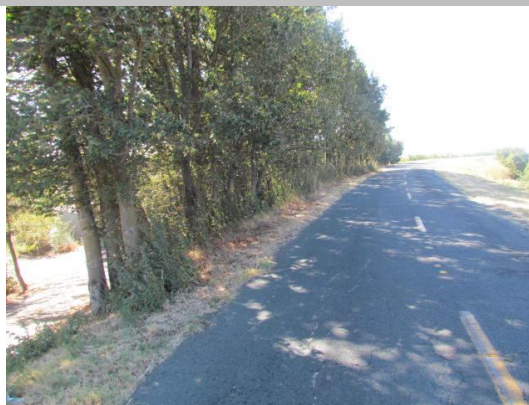
Photo 3 of 3 : SP_2018_RD0003_24_9_20180305_00014.jpg

Looking south at trees on landward shoulder and slope. (Fall 2015)

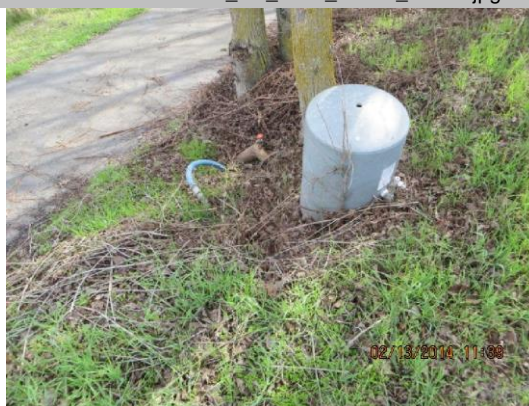
Photo 3 of 3 : UCIP_SP_2018_29530_54590.jpg

Tank on LS shoulder.

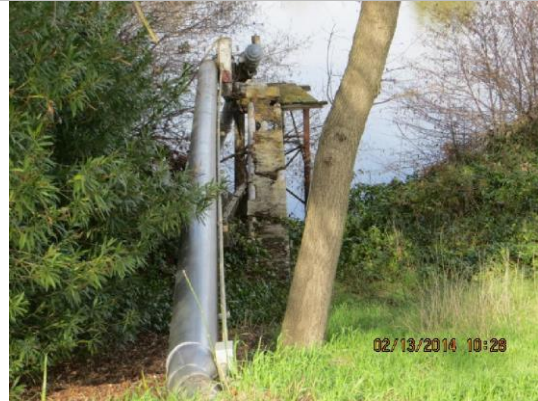
Photo 1 of 3 : UCIP_SP_2018_52541_54546.jpg

Pipe visible on WS slope with slantpump on pier.

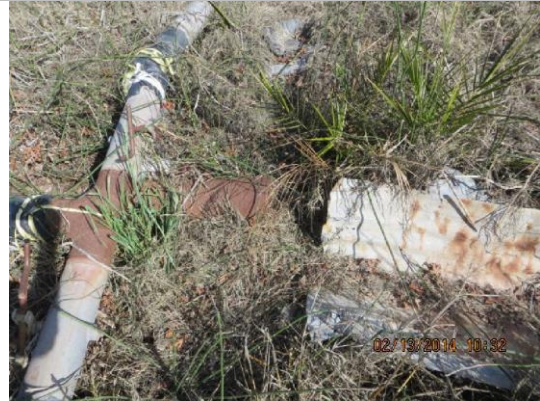
Photo 3 of 3 : UCIP_SP_2018_52541_54544.jpg

Pipe diversion manifold just below siphon breaker on LS slope. Tin diverts water downslope.

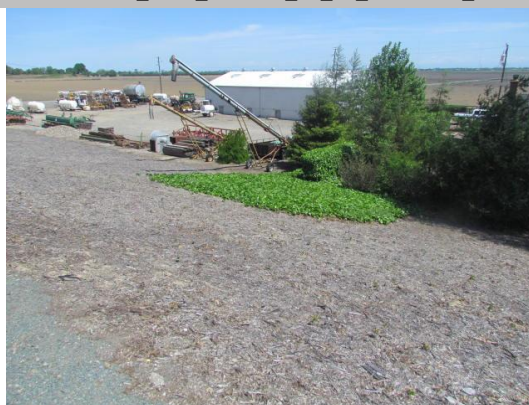
Photo 1 of 1 : SP_2018_RD0003_24_50_20180305_00038.jpg

Looking northeast at landscaping at lower half of landward slope and toe.

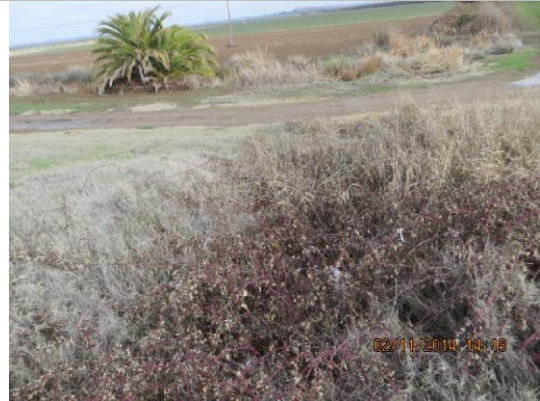
Photo 3 of 3 : UCIP_SP_2018_29823_55103.jpg

Irrigation ditch filled with berries on LS toe.

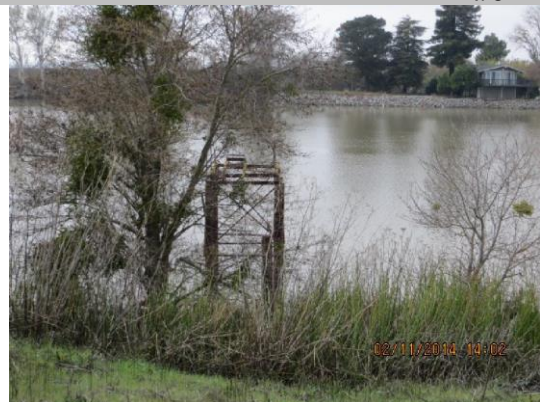
Photo 1 of 3 : UCIP_SP_2018_29403_54462.jpg

Steel pier on WS toe, pipe visible on ground directly in front of pier on slope.

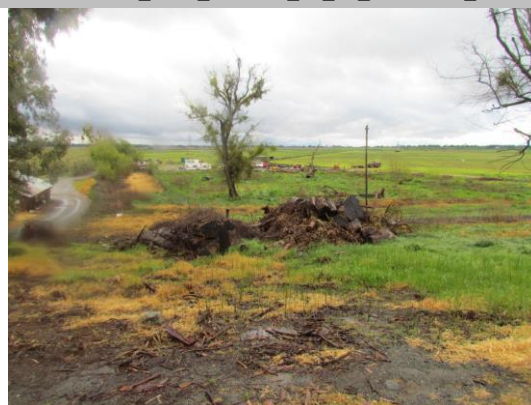
Photo 1 of 1 : SP_2018_RD0003_24_59_20180305_00047.jpg

Looking east at pruning piles on landward berm.

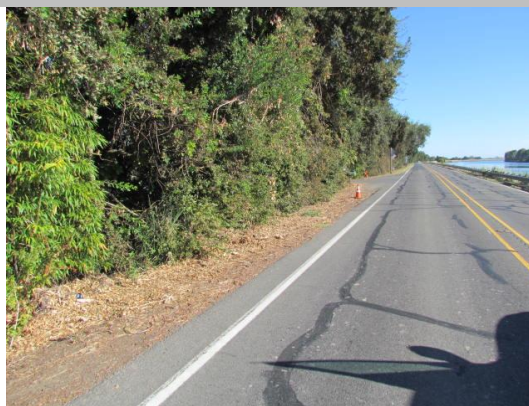
Photo 1 of 1 : SP_2018_RD0003_25_953_20180305_00151.jpg

Looking northwest at dense trees on landward shoulder and slope.

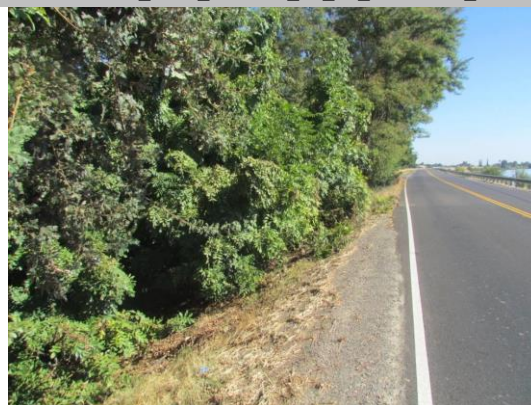
Photo 1 of 2 : SP_2018_RD0003_25_14_20180305_00021.jpg

Looking northeast at dense vegetation on landside shoulder and slope.
(Fall 2016)

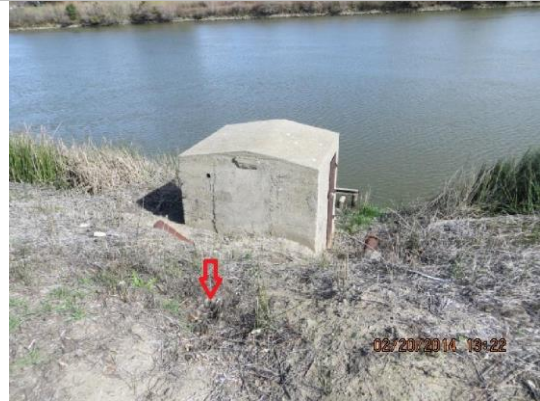
Photo 3 of 3 : UCIP_SP_2018_30648_56412.jpg

Concrete pumphouse on WS shoulder with hole over pipe on WS slope.

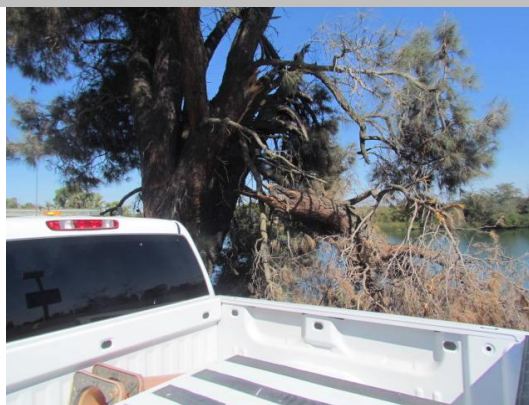
Photo 2 of 2 : SP_2018_RD0003_25_15_20180305_00024.jpg

Looking east at broken and cracked tree branches on waterward slope.

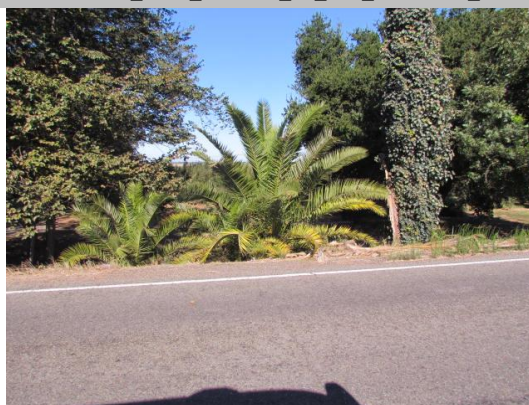
Photo 1 of 1 : SP_2018_RD0003_25_100_20180305_00087.jpg

Looking north at palm trees on landward shoulder and slope.

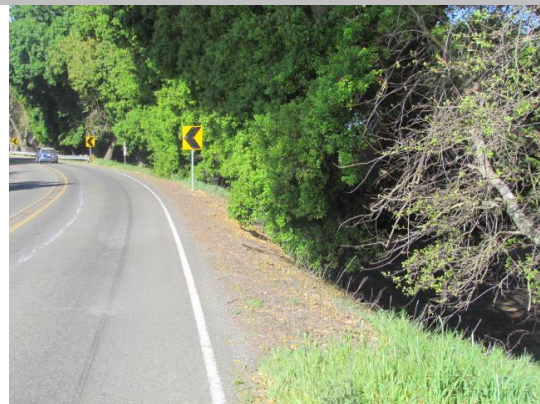
Photo 1 of 1 : SP_2018_RD0003_25_64_20180305_00050.jpg

Looking southwest at dense trees on landward shoulder and slope.

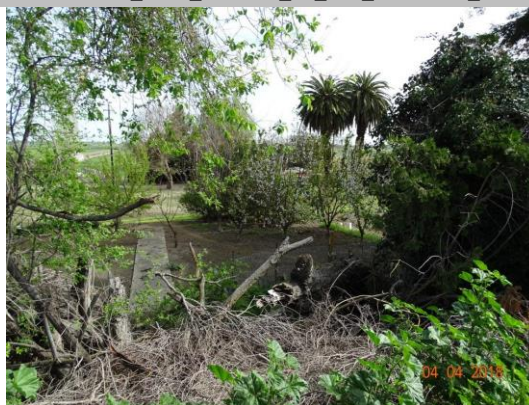
Photo 1 of 1 : SP_2018_RD0003_25_170_20180404_00291.jpg

Fallen tree on landside slope.

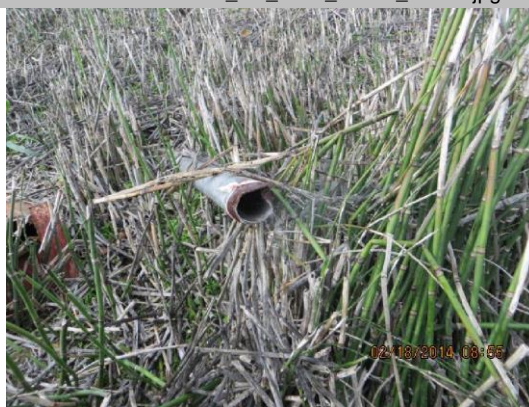
Photo 3 of 3 : UCIP_SP_2018_30204_55603.jpg

Pipe open on both ends.

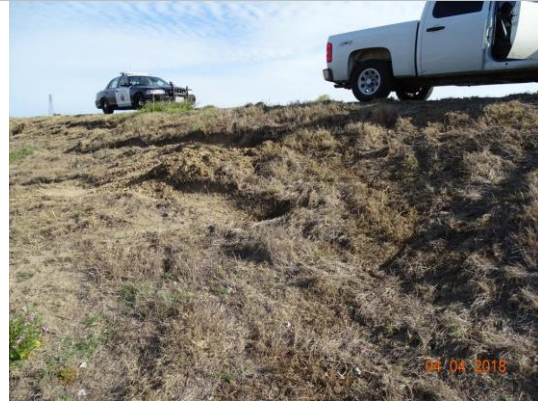
Photo 1 of 1 : SP_2018_RD0003_25_124_20180404_00287.jpg

Vehicle erosion on landside slope should be repaired.
